WESTERN SPINDLE LLC TEST REPORT

STRUCTURAL PERFORMANCE TESTING ON THE 12 FOOT BY 42 INCH URETHANE
BALUSTRADE SYSTEM

80916.02-119-19 R0

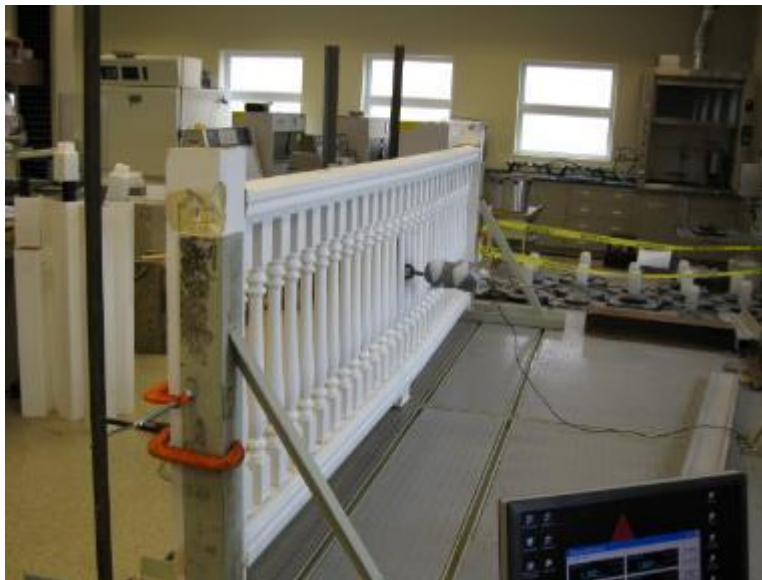
Photo No. 1

In-Fill Load Test at Center of Two Balusters

| Test No. 1 - 04/11/08 | | | | | | |
| Design Load: 50 lb / 1 Square Ft at Center of In-Fill (on Two Pickets) | | | | | | |
| 2.0x Design Load | 107 | 02:03 | 1.09 | 1.30 | 1.05 | 0.23 |
| 2.5x Design Load | 125 | 07:07 | 83% Recovery | | | |

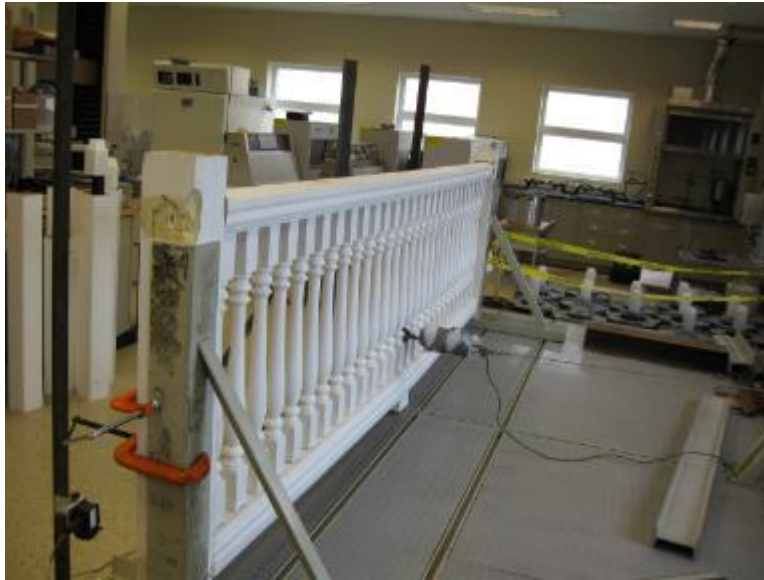
Photo No. 2
In-Fill Load Test at Bottom of Two Balusters

| Test No. 2 - 04/11/08 | | | | | | |
| Design Load: 50 lb / 1 Square Ft at Bottom of In-Fill (on Two Pickets) | | | | | | |
| 2.0x Design Load | 100 | 00:21 | 0.07 | 1.24 | 0.07 | 1.17 |
| 2.5x Design Load | 125 | 04:38 | 78% Recovery | | | |

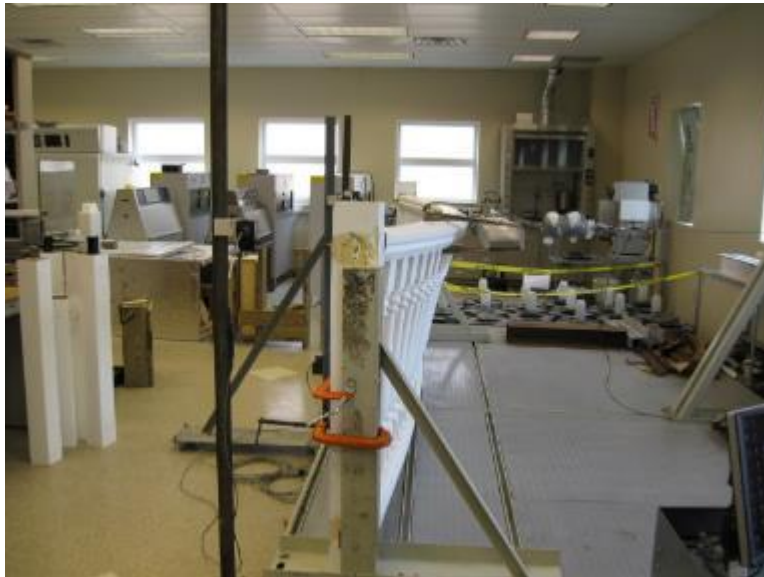
Photo No. 3
Horizontal Uniform Load Test of Top Rail

| Test No. 3 - 04/11/08 | | | | | | |
| Design Load: 50 plf x (144 in ÷ 12 in/ft) = 600 lb Horizontal Uniform Load on Top Rail ¹ | | | | | | |
| 1.67x Design Load | 1008 ³ | 03:55 | 0.39 | 10.78 | 0.46 | 10.36 |
| 2.5x Design Load | 1534 | 08:09 | 80% Recovery | | | |

¹ Uniform load is simulated with 1/4-point loads.

³ The testing was stopped short of the 2.0x design load; therefore recovery value is based on 1.67x design load.

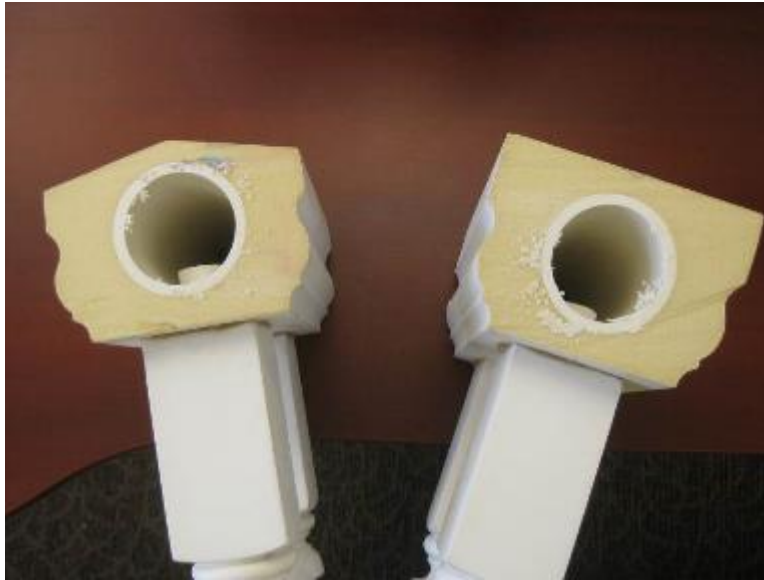
Photo No. 4
Top and Bottom Rail Profiles

Top Rail: 5.550 in wide by 4 in high, low density, polyurethane foam contoured profile with 2.875 in O.D. by 0.225 in wall thickness PVC pipe internal support

Bottom Rail: 5.625 in wide by 4 in high, low density, polyurethane foam flat-top contoured profile with 2.875 in O.D. by 0.225 in wall thickness PVC pipe internal support

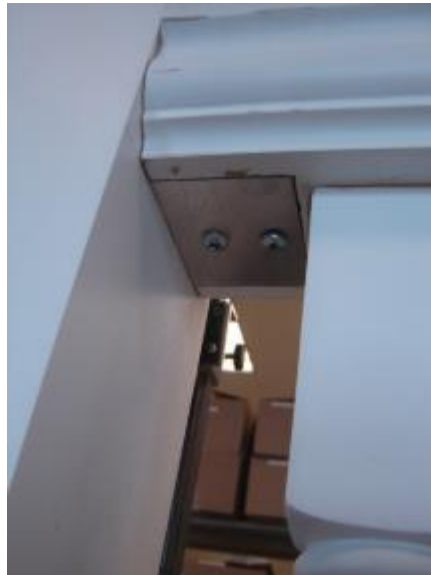
Photo No. 5
Top Rail - Bracket - Post Connection

| Top Rail Bracket to Post ¹ | Two 1/4-20 x 1-1/2 in hex-head bolts with washers and nuts |
| Top Rail to Aluminum Bracket | Two 1/4" x 2" pan-head, zinc-plated screws |

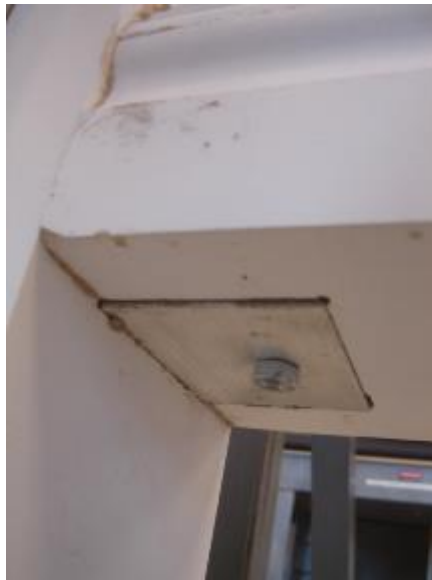
Photo No. 6

Bottom Rail - Bracket - Post Connection

| Bottom Rail Bracket to Post ¹ | Two 1/4" x 2" pan-head, zinc-plated screws |
| Bottom Rail to Aluminum Bracket | One 5/16-18 x 1-1/4" hex-head bolt |
