CENTER FOR ADVANCED MINERAL, METALLURGICAL AND MATERIALS PROCESSING

ASCE Testing of 6in and 4in Rails

8/20/18

Western Spindle, LLC
310 6th St. Townsend, MT 59644

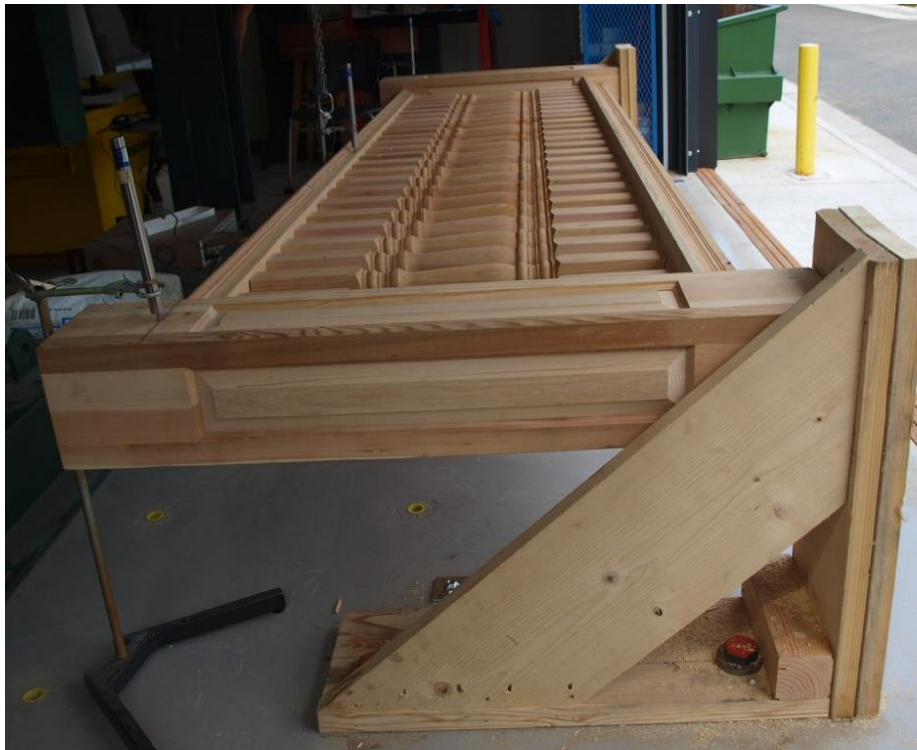
The rails were mounted in a horizontal position so the team could use gravity to simulate the distributed load. The other two test pulled the rail in the opposite direction of gravity, the fixture used and set-up is depicted in Figure 1.

Figure 1: Set-up & fixture for rail testing

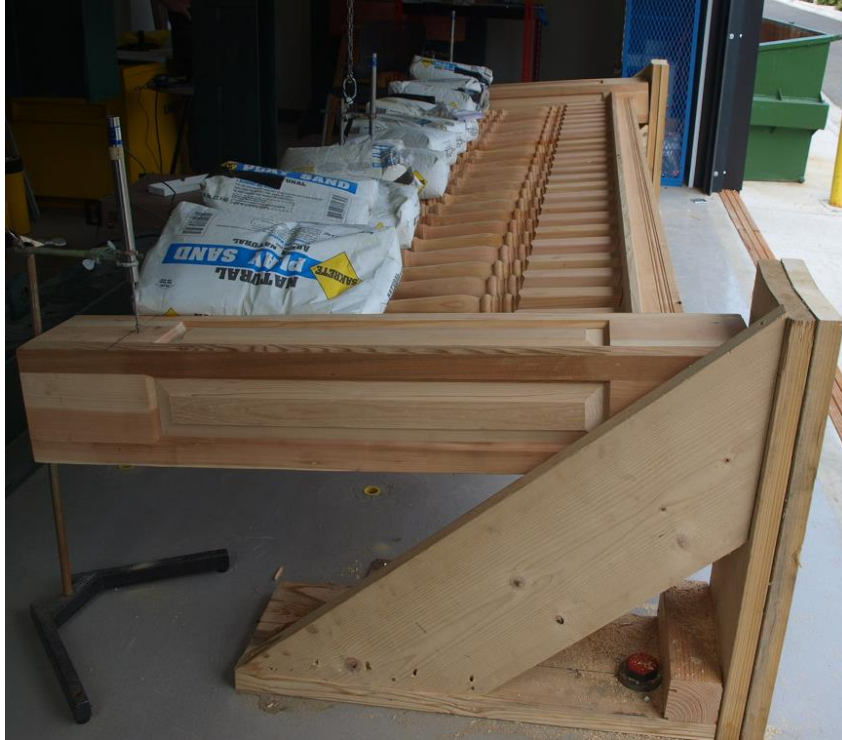
Figure 2 & 3 are the 6in and 4in respectively at the full load during the distributed load test. Both rails had hardware deformation and cracking in the posts. Due to the lack of catastrophic failure the rails were deemed to have passed.

Figure 2: 6in rail at full load of 600lbs during the distributed load test

The distributed load was simulated by using 12 - 50lb sand bags, with two bags being added at a time and 10-15 seconds for the structure to settle and data collected before the next sand bags where added. The sand bags were first added at the center of the rail, and then placed further from center as the number of bags increased. The displacement at both ends of the rail as well as the center were measured using LVDT's, the two ends were averaged to be reported. The max displacement of the LVDT's were 5in, therefore any deflection reporting 5.00 means the actual deflection was 5.00in or greater. Due to the means for calibration, the low end accuracy is poor and is reflected by the values being greater than zero at no load. Table 2 and 3 depict the deflection from the load at the mid and full span for the 6in and 4in rail respectively.

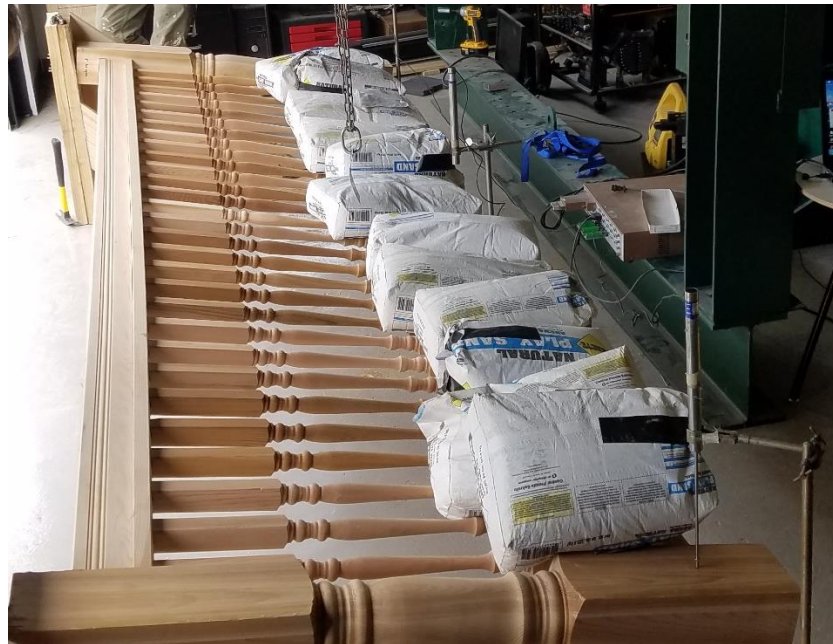
Figure 3: 4in rail at full load of 600lbs during the distributed load test
