CENTER FOR ADVANCED MINERAL, METALLURGICAL AND MATERIALS PROCESSING

ASCE Testing of 6in and 4in Rails

8/20/18

Western Spindle, LLC
310 6th St. Townsend, MT 59644

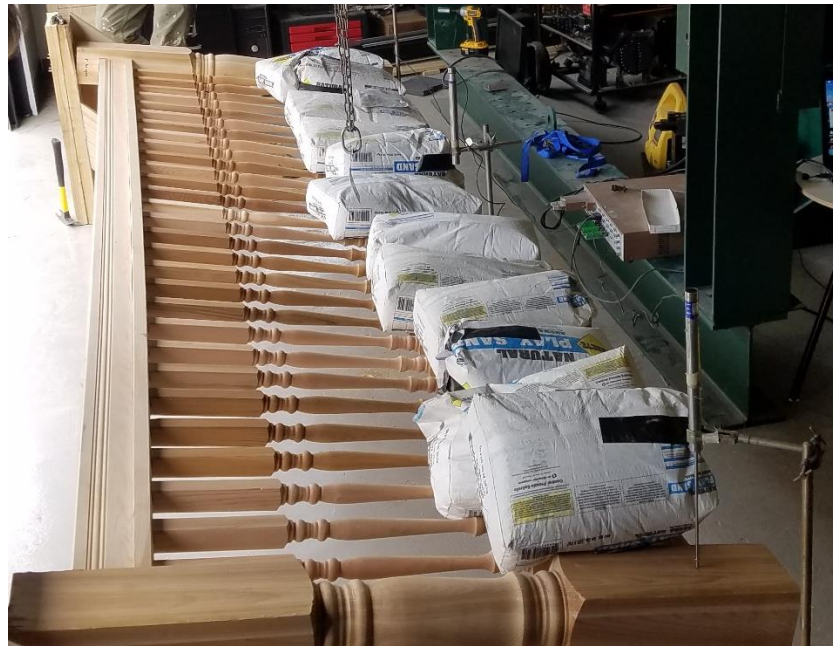
Figure 3: 4in rail at full load of 600lbs during the distributed load test

The distributed load was simulated by using 12 - 50lb sand bags, with two bags being added at a time and 10-15 seconds for the structure to settle and data collected before the next sand bags where added. The sand bags were first added at the center of the rail, and then placed further from center as the number of bags increased. The displacement at both ends of the rail as well as the center were measured using LVDT's, the two ends were averaged to be reported. The max displacement of the LVDT's were 5in, therefore any deflection reporting 5.00 means the actual deflection was 5.00in or greater. Due to the means for calibration, the low end accuracy is poor and is reflected by the values being greater than zero at no load. Table 2 and 3 depict the deflection from the load at the mid and full span for the 6in and 4in rail respectively.

Figure 2 & 3 are the 6in and 4in respectively at the full load during the distributed load test. Both rails had hardware deformation and cracking in the posts. Due to the lack of catastrophic failure the rails were deemed to have passed.
